2009

Completed projects

Watersedge Landslip Remediation, Highton, Geelong, VIC.

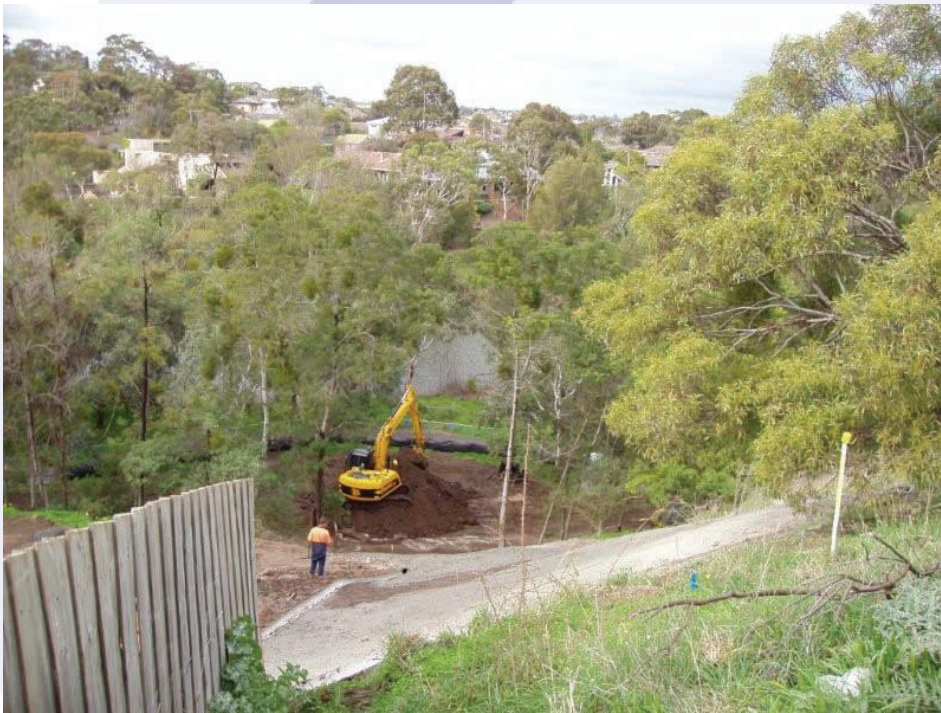
- Working within landslip zone with potential for secondary failure.
- Slope saturation due to leaking existing stormwater bypass.
- Steep site access.
- Redirection and interface with public in CCMA Reserve at base of landslip zone.
- Limited vehicle access to site.

- Site safety monitoring including:
 - Installation of survey control points.
 - Installation and operation of displacement detection system.
 - Groundwater monitoring.
 - Daily visual inspections and survey checks.
- Excavation of landslip zone.
- Controlled placement and compaction of FCR.
- Installation of subsurface drainage and geotextiles.
- Redirecting existing storm water system and decommissioning of failed existing drainage.
